**FINAL REPORT  
AUGUST 2000**

**REPORT NO. 98-09**

**M3A1 HYUNDAI  
CONTAINER ROLL-IN/ROLL-OUT  
PLATFORM (CROP)  
TP-94-01, Transportability Testing Procedures**

The U.S. Army Defense Ammunition Center (DAC), Validation Engineering Division (SMAAC-DEV), was tasked by the U.S. Army Tank-automotive and Armaments Command to conduct a First Article Test (FAT) on the Container Roll-In/Roll-Out Platform (CROP) manufactured by Hyundai Precision America, San Diego, California.

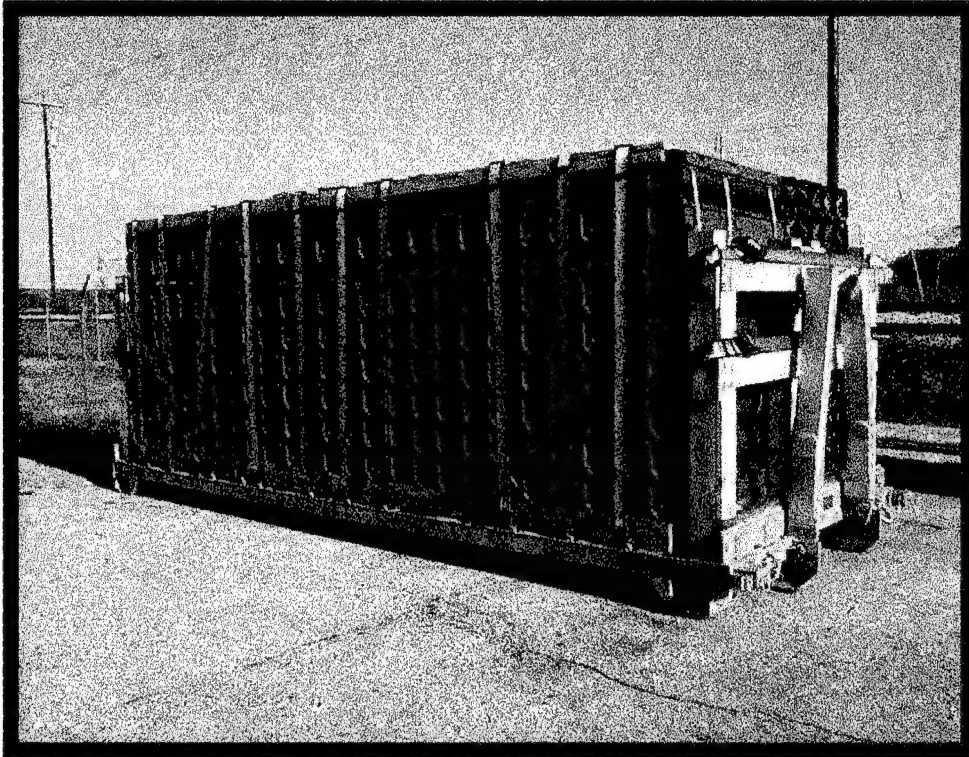
**Photo No. 2. 120MM on the CROP**

Specimen Load: 120MM and 155MM on CROPs and secured to wood deck railcar.

Remarks: No problems with CROPs and/or loads. The CROP with 155MM load has aluminum side strips. (See Photo 2).

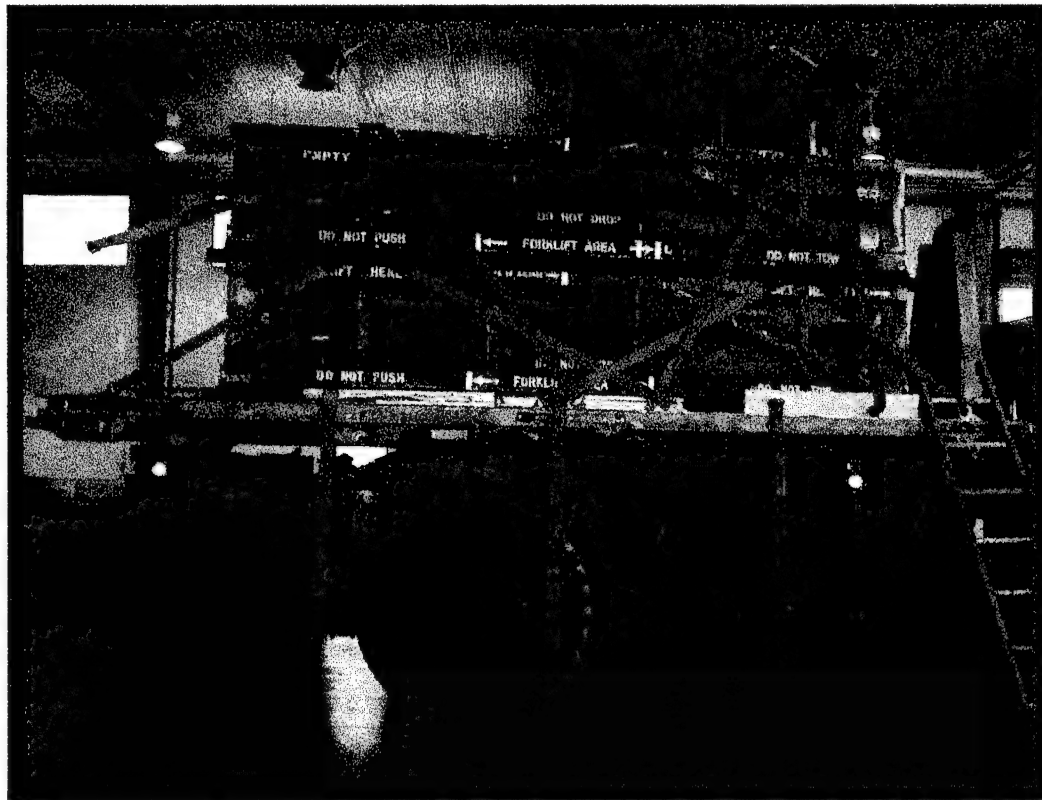
**Photo No. 4.** MLRS pods on the CROP on the PLS trailer

Specimen Load: MLRS on PLS trailer and chained to flatcar.

Remarks: No problems with the CROP and/or load.

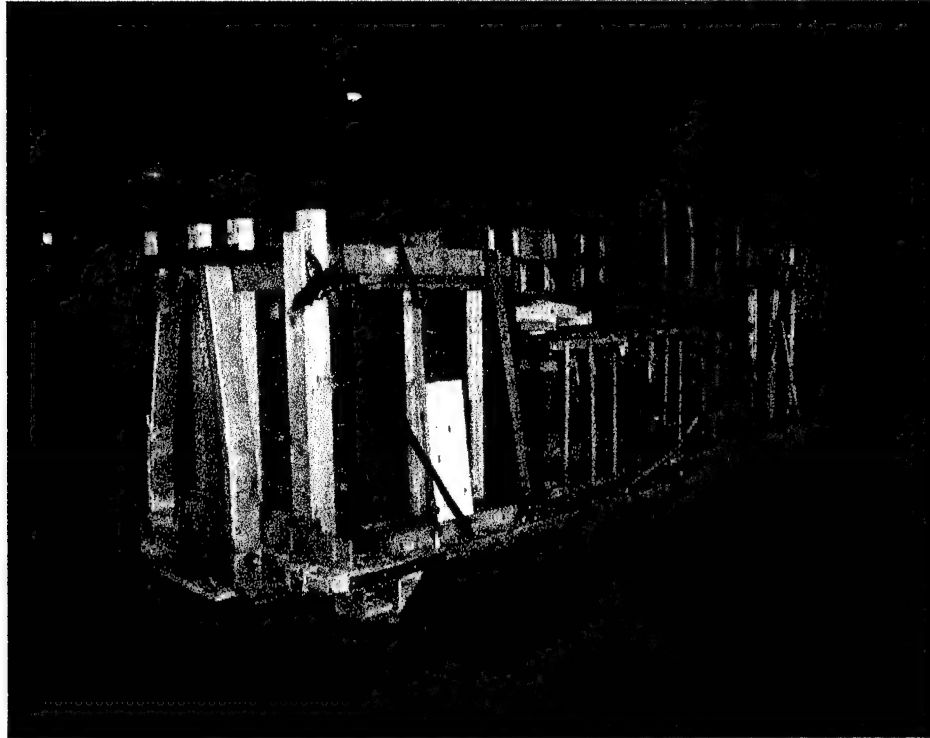
**Photo No. 5. SCL #23 on the CROP**

Specimen Load: Strategic Configured Load (SCL) 23 on the PLS trailer.

Remarks: Pin fell out of right rear restraint wall. Pin fell out of center rear restraint wall. Side blocking needed. Summa trailer interface kit incompatible with Hyundai CROP. (See Photo 5).

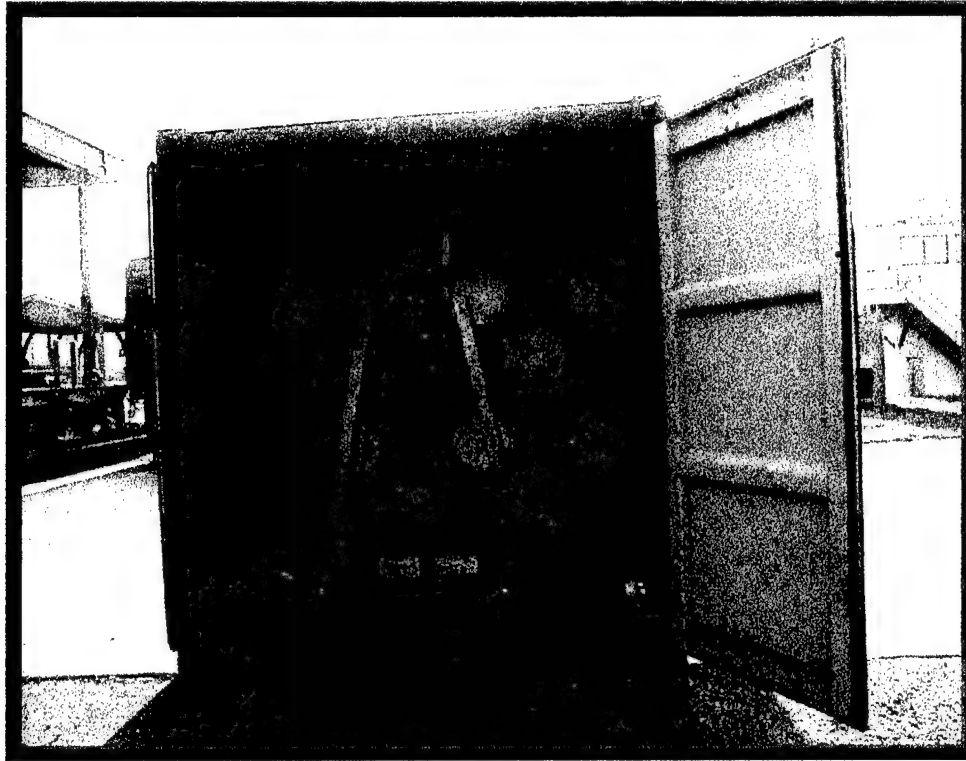
**Photo No. 6. MLRS pods on the CROP in an ISO container**

Specimen Load: 105MM and MLRS in ISO container.

Remarks: No problems with the PLS. On MLRS the skids dished out CROP floor. The forward load restraint device dislodged.

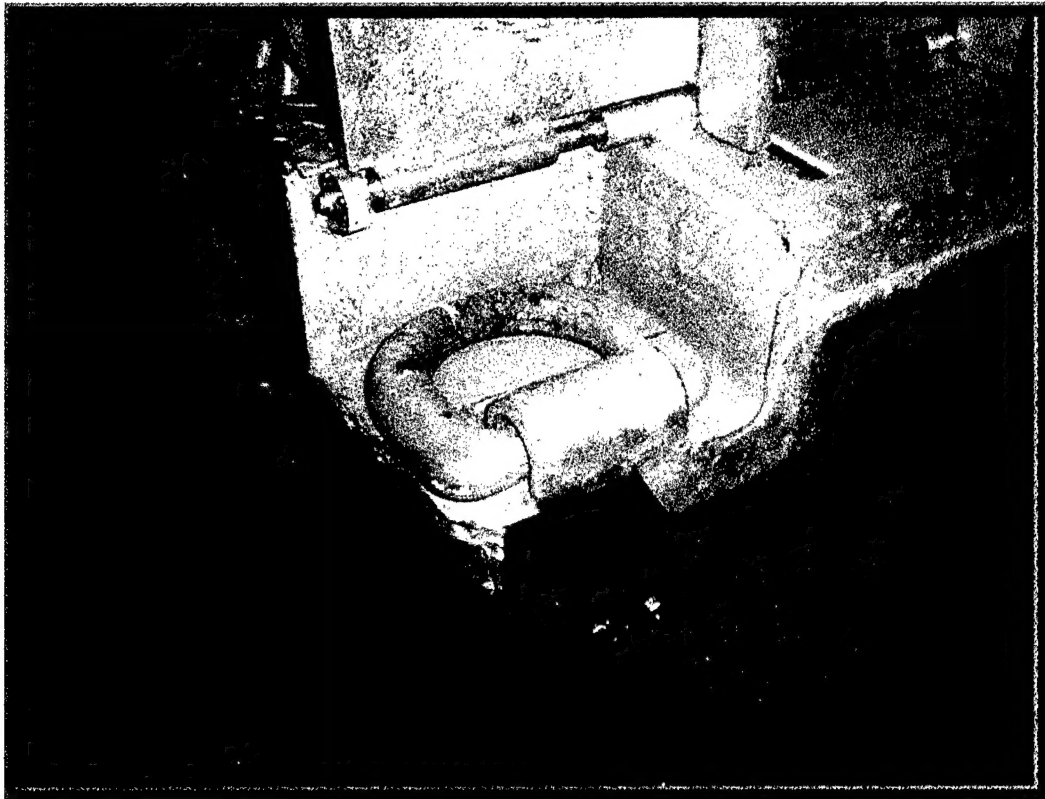
**Photo No. 7. Rear Bumpers**

3. The rear bumpers strike the ground before the rollers. As a result, they wear off very easily. If not corrected the bumpers will not survive in service.
